**PROPERTY INSPECTION REPORT**

**Concerning:** 1234 Sample Court, San Antonio, Texas 78260  
(Address or Other Identification of Inspected Property)

**By:** Perry Zelner #7019 February 18, 2016  
(Name and License Number of Inspector) (Date)

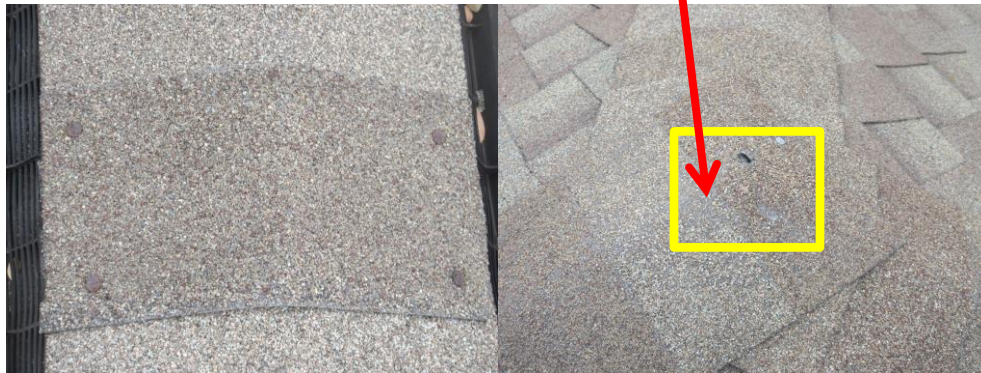
Per current accepted trade practices, exposed nail heads and openings at the ridges and roof penetrations should be sealed to reduce the risk of leaks.

Portions of the roofing system are showing signs of wear. Client may want to consider additional inspection(s) based on the age and or levels of assumed risk. (red arrow above)

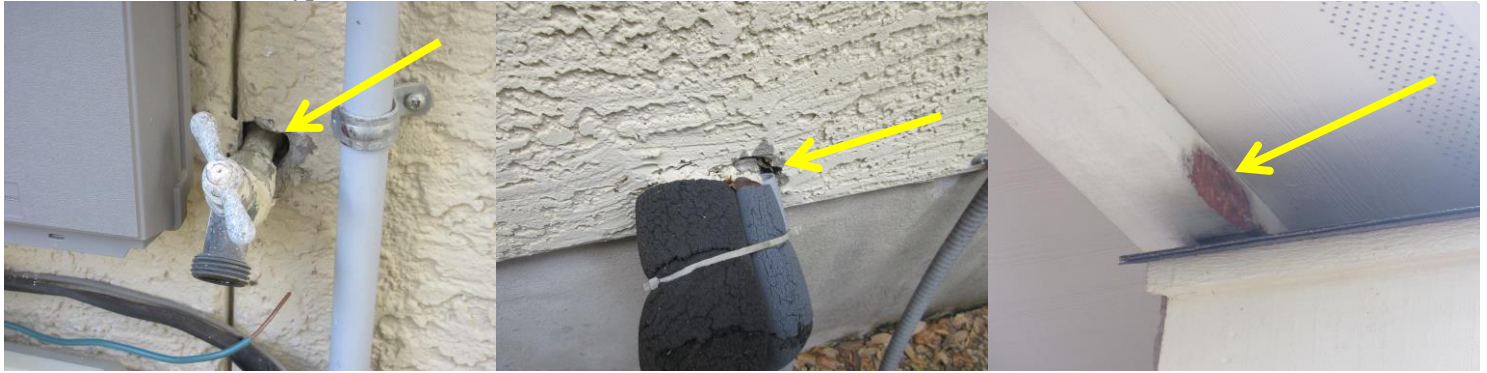
Recommend all openings are properly sealed.

Cracks were observed in the exterior brick walls of the structure. This implies that some structural movement of the structure has occurred, as is typical of most structures.

Much of the exterior trim is in need of sealing and paint. Signs of dry rot were observed at the trim at various locations.

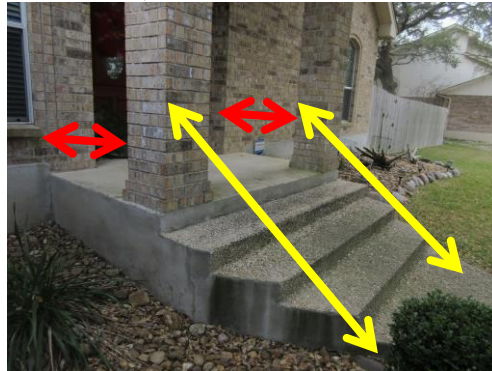
Per current accepted trade practices, a hand rail should be added to the front exterior steps. Hand rails should be provided when an elevation change of 4 or more risers occur. (yellow arrows)

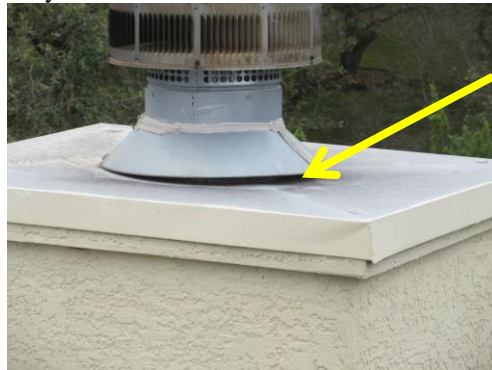
Recommend the fireplace storm collar is properly re-positioned and sealed to prevent moisture intrusion.

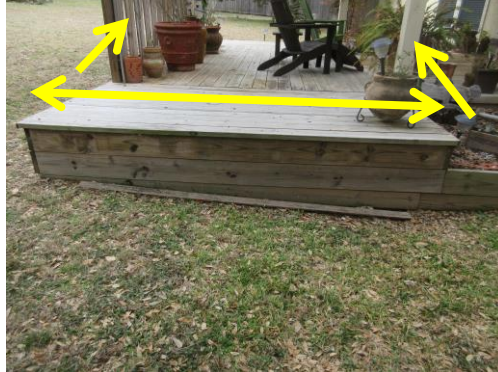
Per current accepted trade practices, recommend guard railings for proper safety.

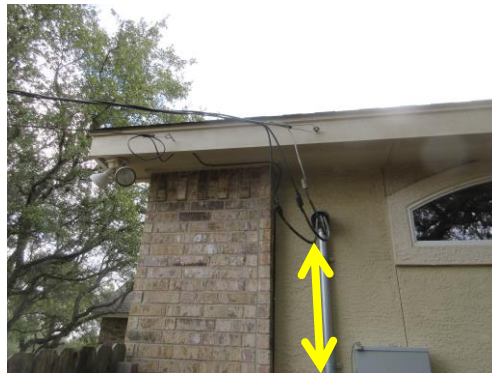
Per current accepted trade practices, the service entry wires do not have the proper clearance of 10 feet from the grade to the bottom of the drip loop.

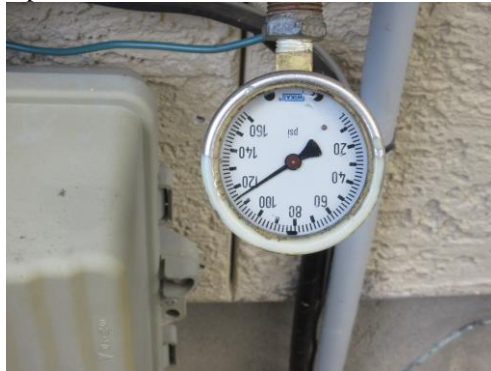
Water pressure over 80 psi. can cause internal fixture damage. Recommend the adjustment/replacement of the pressure reducing valve by a licensed professional prior to the option period expiring.

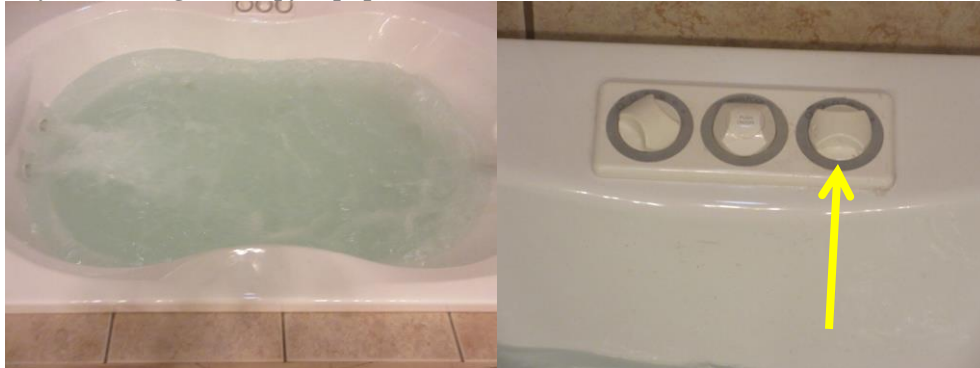
In this inspector's opinion, the hydro-massage therapy equipment performed as intended at the time of inspection.

A damaged control knob.

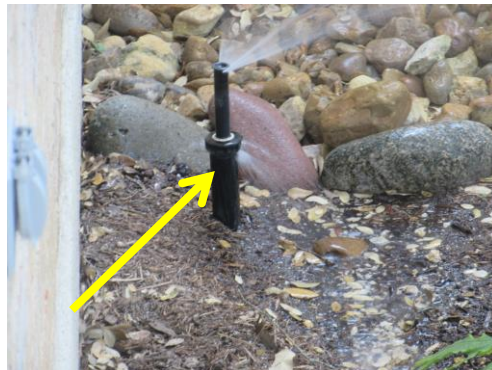
Damaged spray head at zone #2.

Recommend the entire sprinkler system is serviced by a licensed professional prior to the option period expiring.
