## PROPERTY INSPECTION REPORT

**Concerning:** 1234 Ryland Downs, San Antonio, Texas 78250  
(Address or Other Identification of Inspected Property)

**By:** Perry Zelner #7019 March 25, 2020  
(Name and License Number of Inspector) (Date)

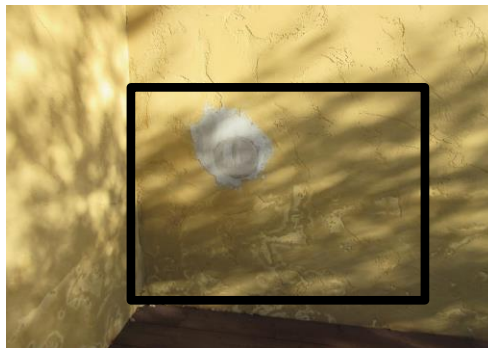
Patching was noted at the rear of the structure. Recommend the buyer seeks additional information from the seller regarding the purpose of the patching.

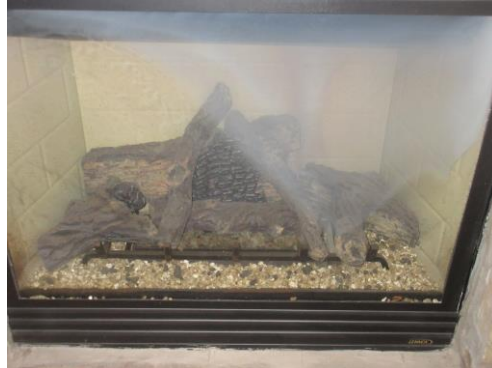
Fogged glass at the Heatilator

**Noted the smell of natural gas when the Heatilator was energized. Recommend this condition is further evaluated by a licensed professional prior to the option period expiring.**

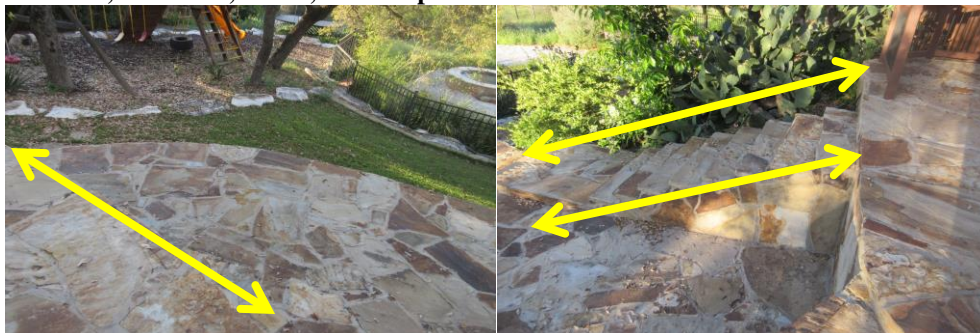
Per current accepted trade practices, recommend guard railings at the rear porch area for proper safety.

Per current accepted trade practices, a hand rail should be added to the exterior rear steps. Hand rails should be provided when an elevation change of 4 or more risers occur.

The construction of the rear deck does not meet current accepted trade practices for 4 x 4 post support. This condition is prone to rot and insect activity.

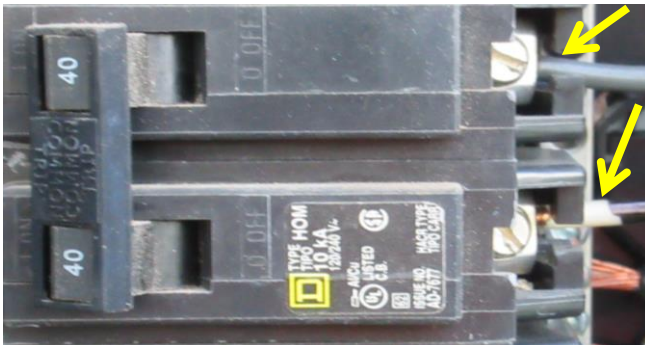
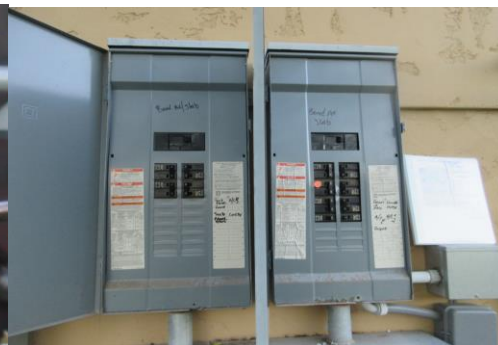
Main service panel #1 and #2.

The wire size that serves the 40 amp breaker in main service panel #2 appears to be incorrect. This should be furthered evaluated by a licensed professional prior to the option period expiring.

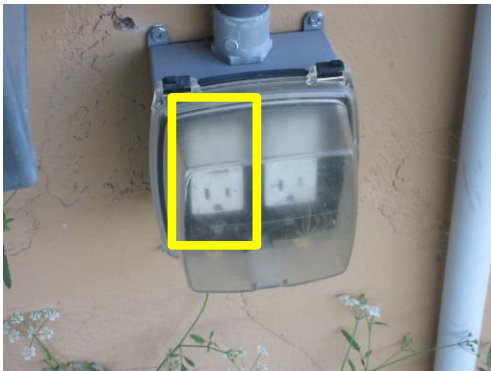
Damaged GFCI protected receptacle located at the main service panels.

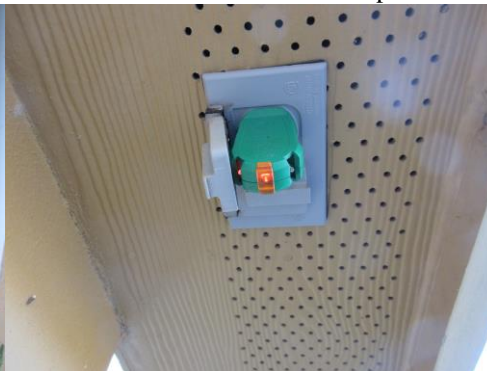
Per current accepted trade practices, all exterior receptacle should be GFCI protected.

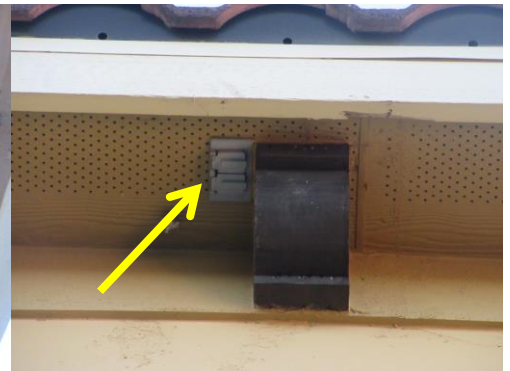
Due to excessive height, various exterior receptacles were not tested and not confirmed for GFCI protection.

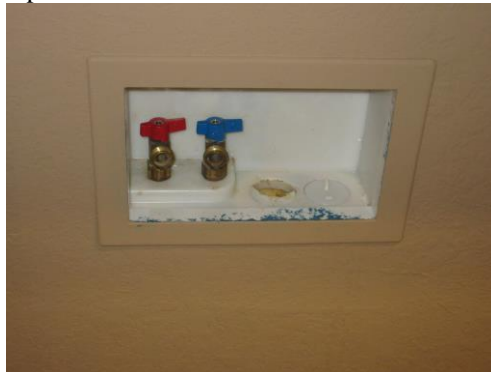
Due to the possibility of the clothes washer hose bibs not shutting off, the hose bibs were not tested for functional water flow.

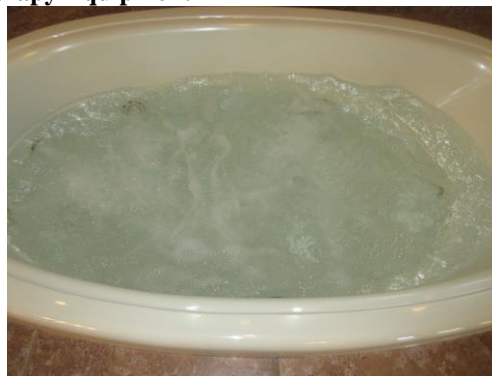
In this inspector's opinion, the hydro-massage therapy equipment performed as intended at the time of inspection.

The pump(s) were very slow to start. However, after attempting to energize the system numerous times the pumps finally started. Due to this condition, recommend the system is service by a licensed professional prior to the option period expiring.

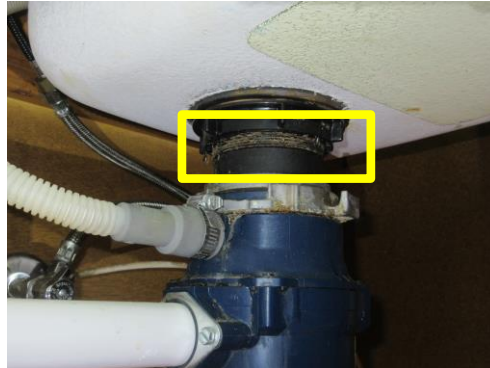
Leak noted at the connection of the sink and disposer.

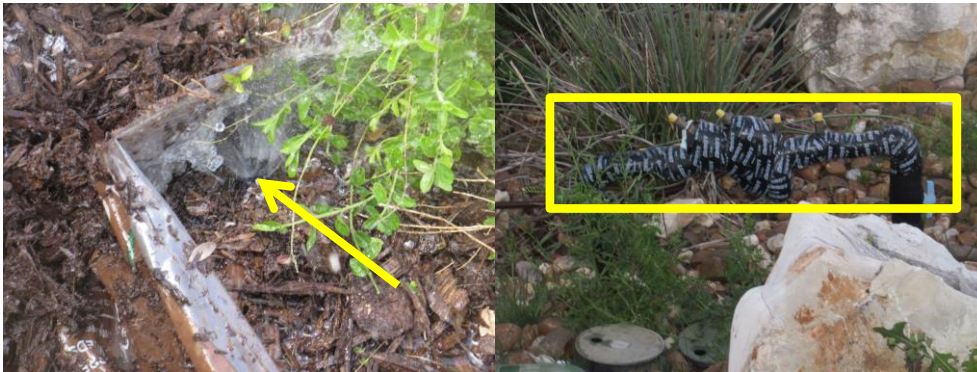
Leak at zone #7 drip system.

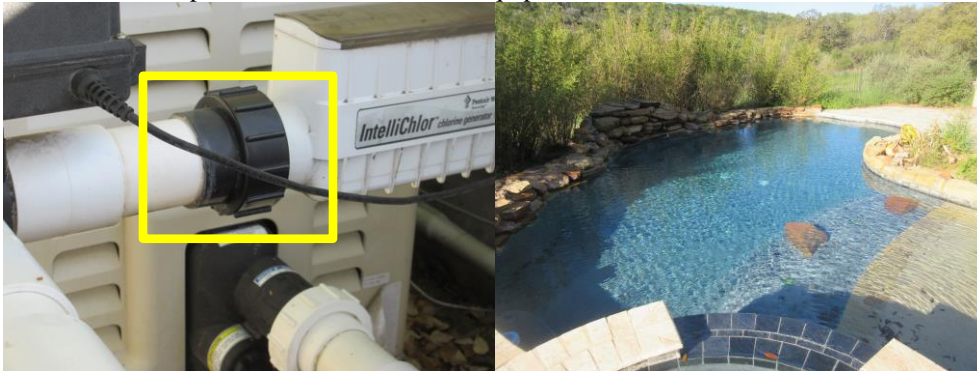
Leaks noted at the pool supply line.
