## PROPERTY INSPECTION REPORT

**Concerning:** 1234 Sample Trail, San Antonio, Texas 78253  
(Address or Other Identification of Inspected Property)

**By:** Perry Zelner #7019  
(Name and License Number of Inspector)

January 27, 2016  
(Date)

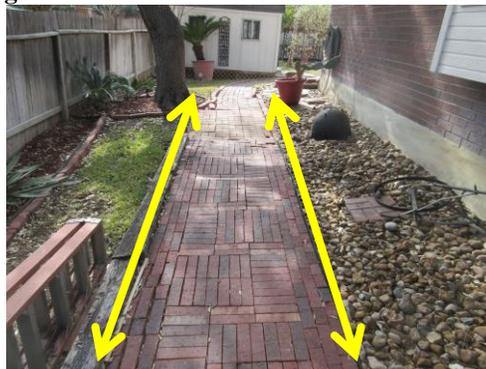
Trip hazards noted all around the structure.

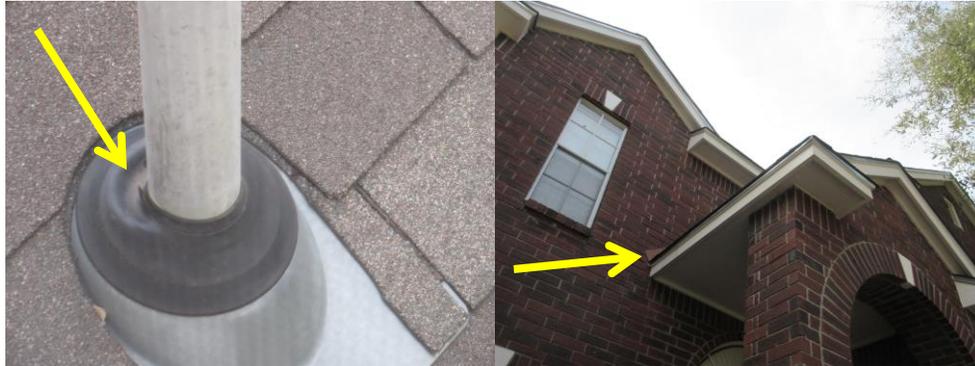
An inverted roof jack seal was noted. As these seals age and deteriorate; this is a potential moisture intrusion point.

Per current accepted trade practices, a “kickout” to divert rainwater from the structure is missing at the right and left side of the front door gable.

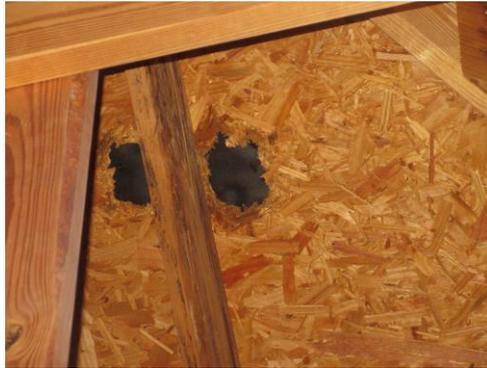
Damaged roof decking noted.

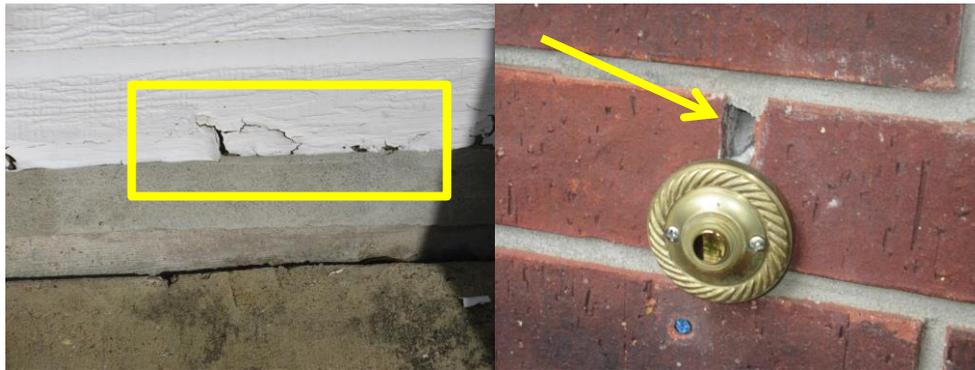
The majority of the wood siding/soffit is made of a fibrous wood product if not properly sealed and painted, deteriorates quickly. Damage was observed at various locations of the exterior. Recommend all openings are properly sealed.

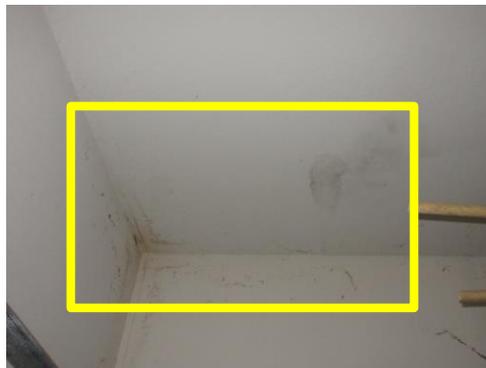
Water staining was noted in but may not be limited to the garage. Buyer may want to consider additional inspections based on the age, unknown(s), levels of assumed risk, or by a licensed professional prior to the option period expiring. Recommend the buyer seeks additional information from the seller on how these stain(s) occurred.

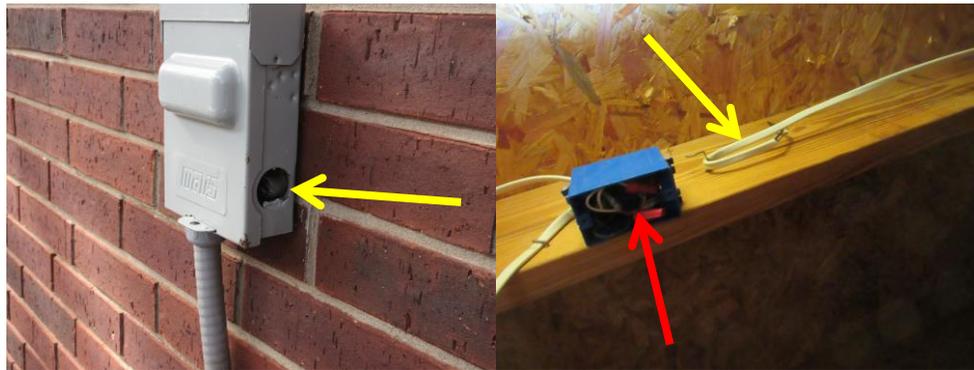
Per current accepted trade practices, opening(s) in the A/C disconnect panel should be covered with listed filler plates.

Incomplete master bedroom attic light fixture was noted. Missing junction box cover was noted. (red arrow)

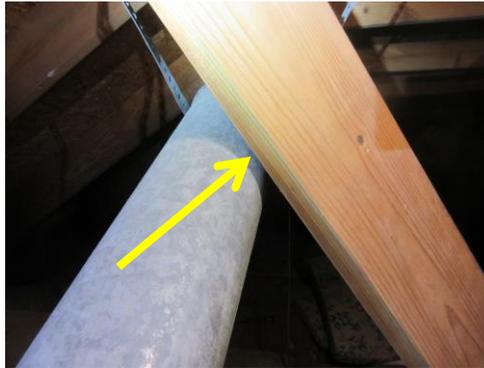
The furnace exhaust flue is too close to combustibles.

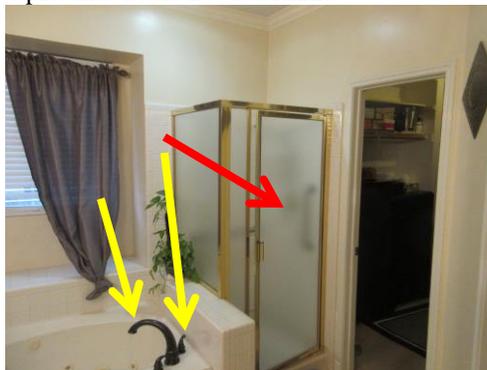
Loose faucet and hot water handle at the master bathroom tub. (yellow arrows)

The master bathroom shower faucet handle is not properly installed. (red arrow)

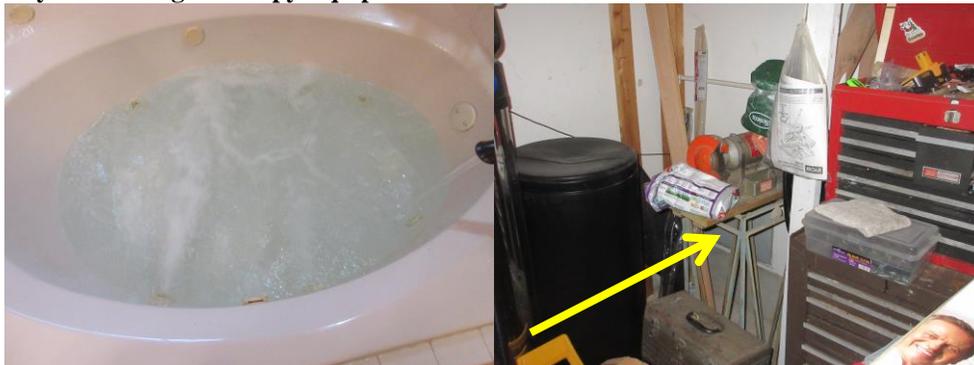
Due to the garage storage, inspection of the access panel was not possible.

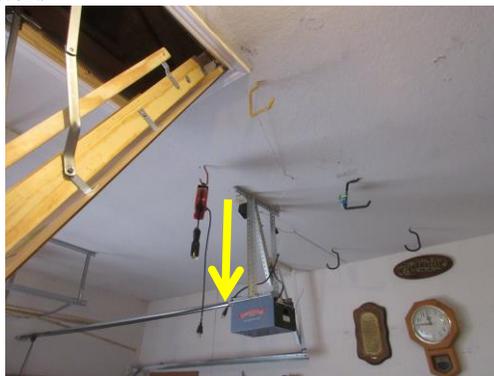
The northeast garage door opener was not energized at the time of inspection.

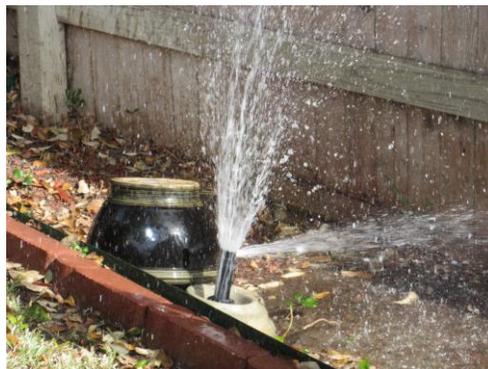
Malfunctioning sprinkler heads at zone #1 and zone #4

Recommend the entire sprinkler system is serviced by a licensed professional prior to the option period expiring.

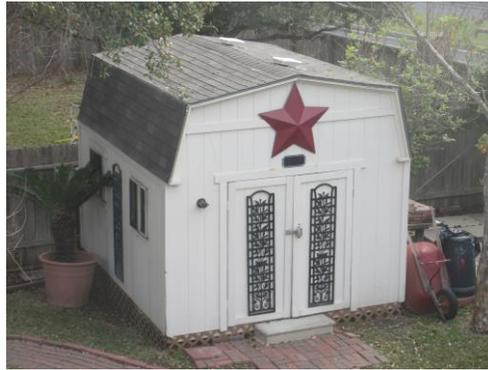
The back yard storage shed and all related components were not inspected.
