PROPERTY INSPECTION REPORT

Concerning: 1234 Sample Street, San Antonio, Texas 78261
(Address or Other Identification of Inspected Property)

By: Perry Zelner #7019
(Name and License Number of Inspector)

January 28, 2016
(Date)

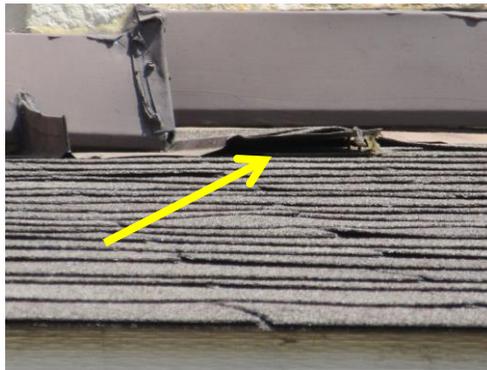
Lack of maintenance and sealing of all flashing material may be expected to contribute to roof leakage points. Buyer may want to consider additional roof inspections based on the age, unknowns, and or levels of assumed risk.

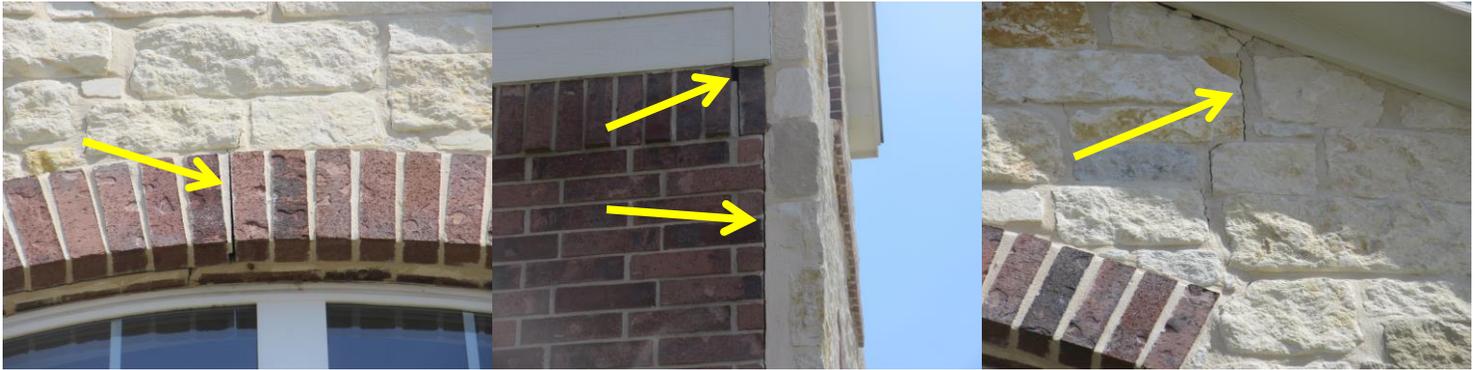
Cracks were observed in the exterior brick/stone walls of the structure. This implies that some structural movement of the structure has occurred, as is typical of most structures.

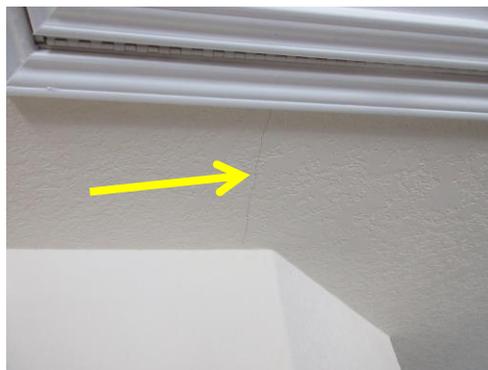
Crack(s) were observed in the ceiling of the structure. This implies that some structural movement of the building has occurred, as is typical of most structures. (See photo above)

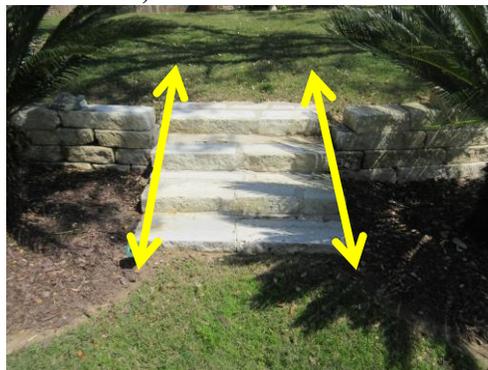
Per current accepted trade practices, a hand rail should be added to the exterior steps. Hand rails should be provided when an elevation change of 4 or more risers occur.

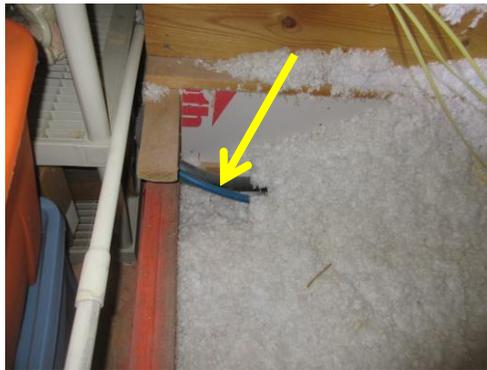
The water supply lines running through the house is a material called “PEX”. The fittings used in joints have been known to fail causing water damage. It is beyond the scope of this non-destructive inspection to determine if these fittings have failed or will fail. To keep PEX pipe warranty in force, recommend all PEX water supply lines in the attic are properly insulated and protected from UV rays. Recommend the buyer seek additional information from the builder, seller(s), or from a licensed professional with knowledge about these failures.

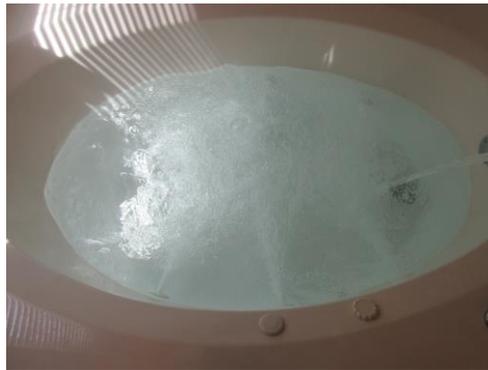
In this inspector's opinion, the hydro-massage therapy equipment performed as intended at the time of inspection.
