Customer: Joe Sample

Property Address: 1234 Sample Avenue, San Antonio, Texas 78260

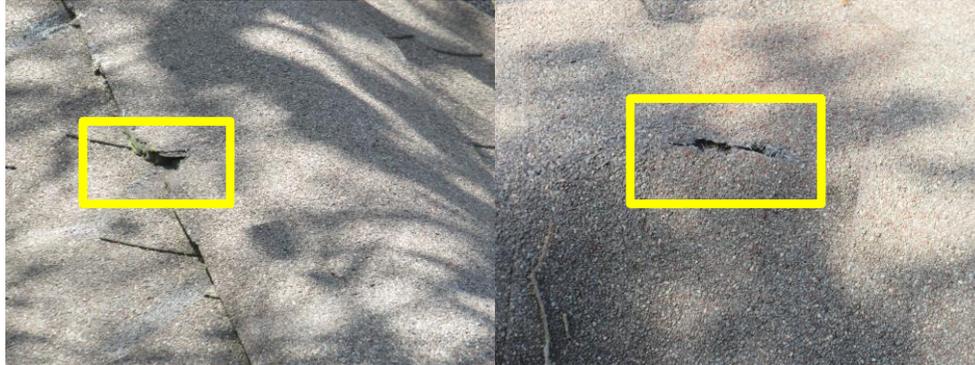
Damaged shingle(s) were noted.

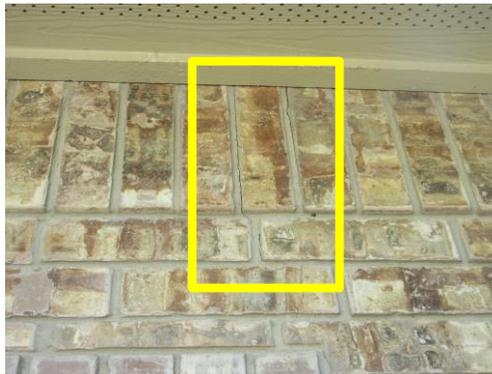
Cracks were observed in the exterior brick walls of the structure. This implies that some structural movement of the structure has occurred, as is typical of most structures.

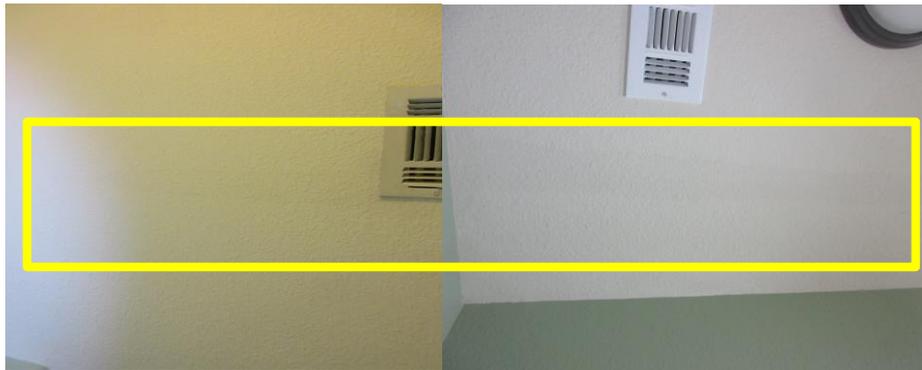
Water staining was noted in but may not be limited to the southeast bathroom. Buyer may want to consider additional inspections based on the age, unknown(s), levels of assumed risk, or by a licensed professional prior to the option period expiring. Recommend the buyer seeks additional information from the seller on how this stain(s) occurred.

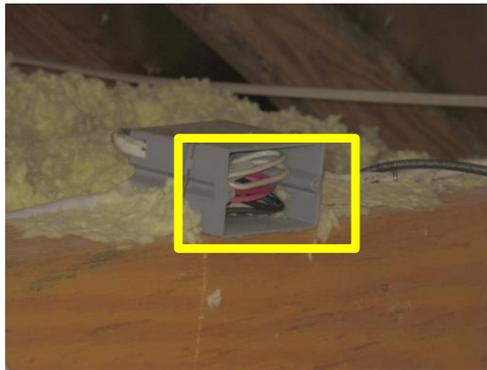
Per current accepted trade practices, electrical wiring in a junction box should have a proper cover. (attic)

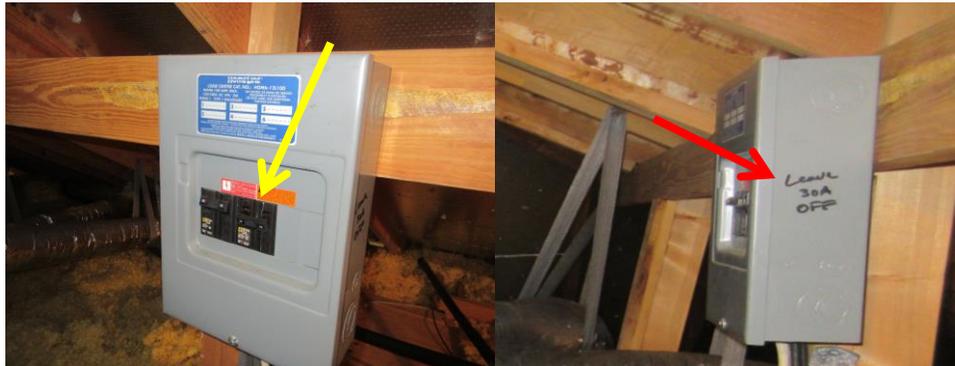
The 30 amp breaker in the air handler electrical disconnect service box was not energized at the time of inspection. Testing of the emergency heat cycle indicated different temperatures in various interior locations. This breaker appears to be serving the emergency heat cycle. Recommend the non energized breaker and the emergency heating system is further evaluated by a licensed professional prior to the option period expiring. (see writing on the electrical panel disconnect box, red arrow)

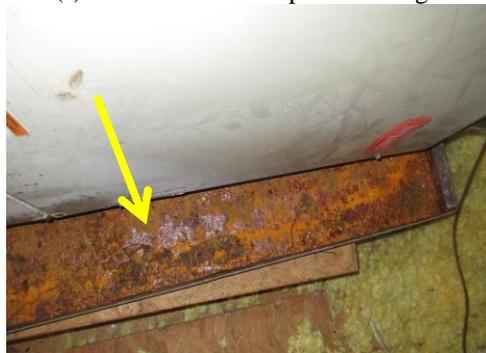
Rust was noted in the secondary drain pan. This is an indication of a lack of service and maintenance. Recommend a licensed professional inspect the secondary drain pan for integrity.

Recommend the installation of a float switch in the secondary drain pan.

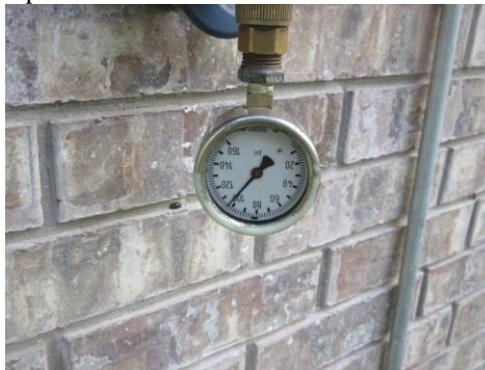
Water pressure over 80 psi. can cause internal fixture damage. Recommend the adjustment/replacement of the pressure reducing valve by a licensed professional prior to the option period expiring.

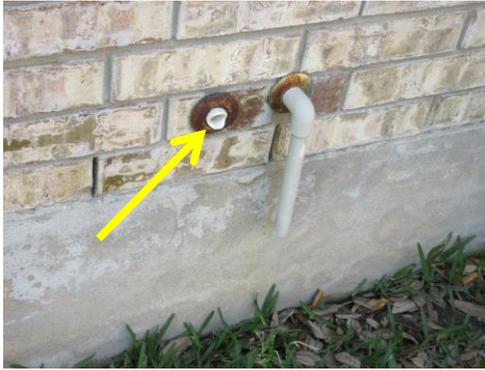
Damaged water heater discharge tube.

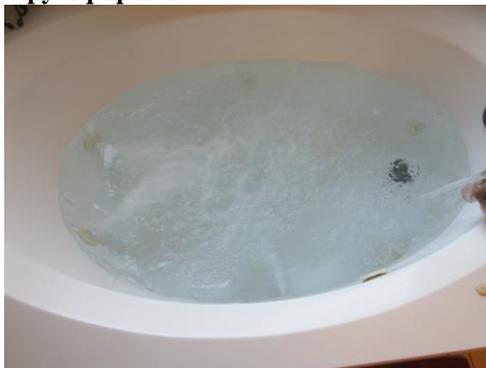
In this inspector's opinion, the hydro-massage therapy equipment performed as intended at the time of inspection.

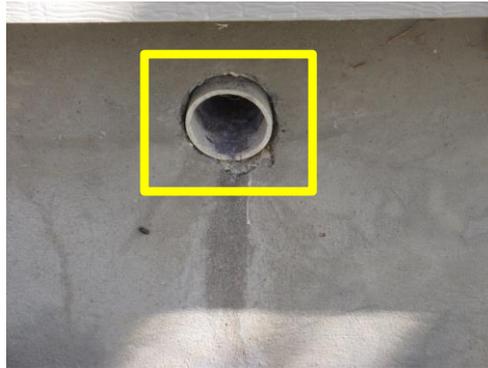
Per current accepted trade practices, an approved exterior dryer vent cover with a damper is recommended.

Recommend the dryer vent tube is cleaned.

Per current accepted trade practices, smooth wall metal pipe is recommended for the dryer vent.

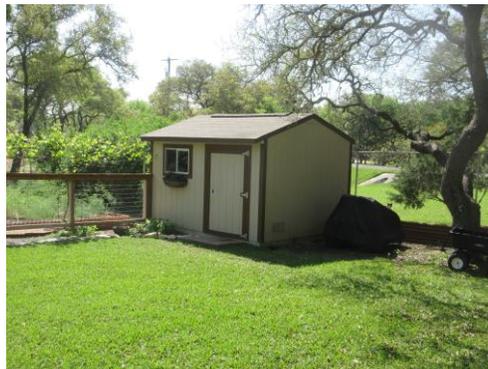
The back yard storage shed and all related components were not inspected.
