**PROPERTY INSPECTION REPORT**

Concerning: #25 Rimrock Canyon, San Antonio, Texas 78258  
 (Address of Other Identification of Inspected Property)

By: Perry Zelner #7019  
 (Name and License of Inspector)

December 12, 2005  
 (Date)

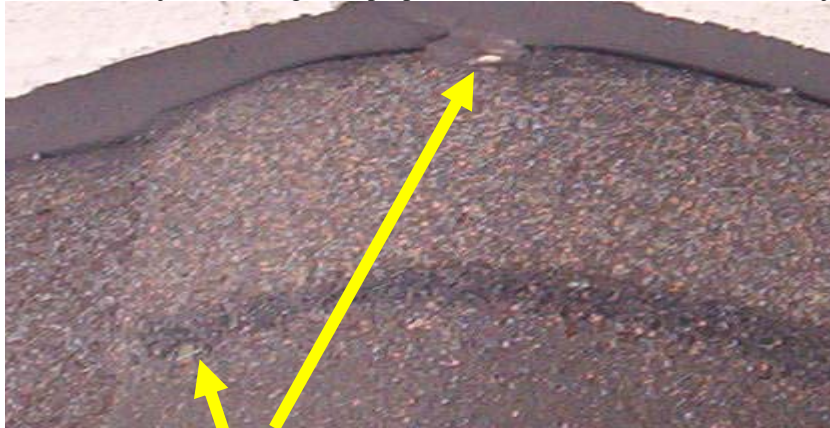
Exposed nail heads that need sealing

Per current accepted trade practices, exposed nail heads at the ridges and roof penetrations should be sealed to reduce the risk of leaks.

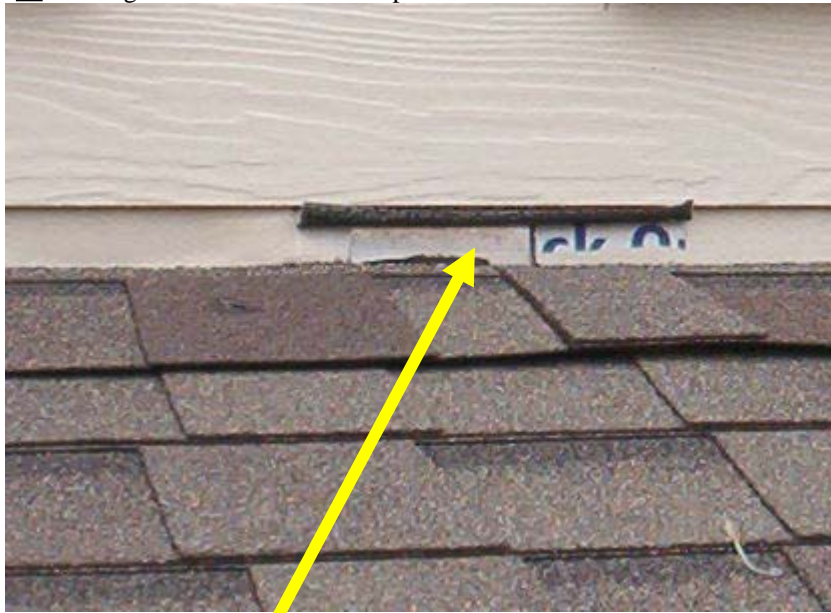
Loose vinyl covering that covers metal flashing, over rear patio

Improper construction and installation of flashing material may be expected to contribute to roof leakage points.

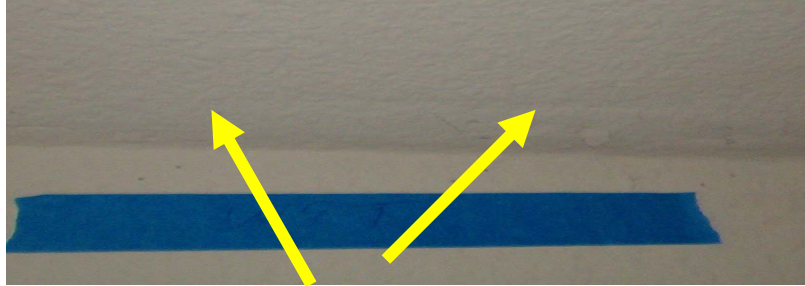
Damaged wall in the upstairs office

Damage was noted in the upstairs office and should be repaired.

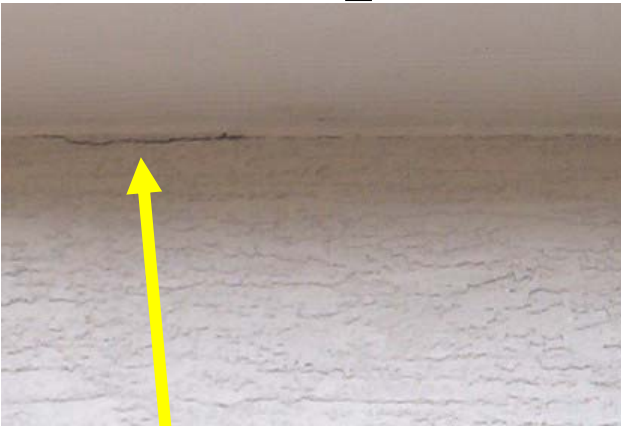
Crack in the hard coat system on the west side under the soffit area.

Small hairline cracks were noted throughout the entire hard coat system (stucco). The hard coat system does not appear to have been installed per current standards for proper moisture drainage including a proper foundation weep screed. This could lead to cracking, and moisture penetration behind the walls. It is recommended that the buyer meet with the contractor to verify proper function of the hard coat system (stucco).

A small crack was noted at the west side of the house under the soffit and should be repaired.

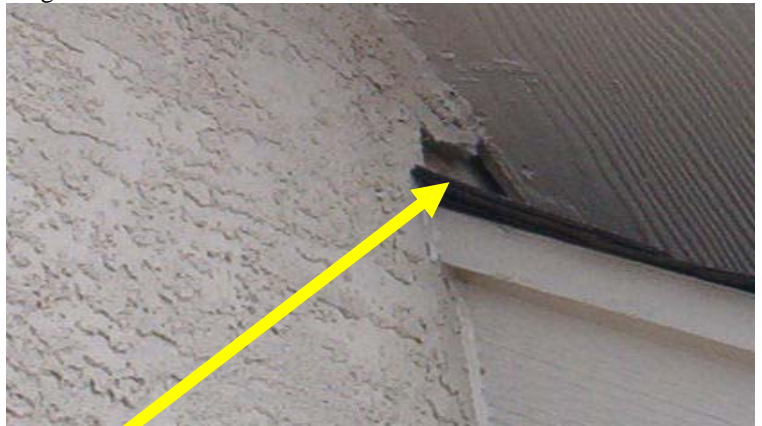
Vulnerable area on the south side upper level

A vulnerable area was noted at the south side on the lower level of the roof. Repairs should be undertaken to prevent damage.

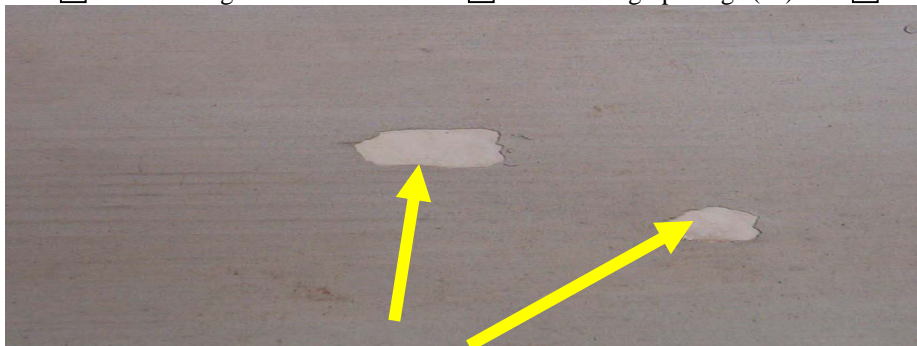
Damaged porch coat on the rear patio

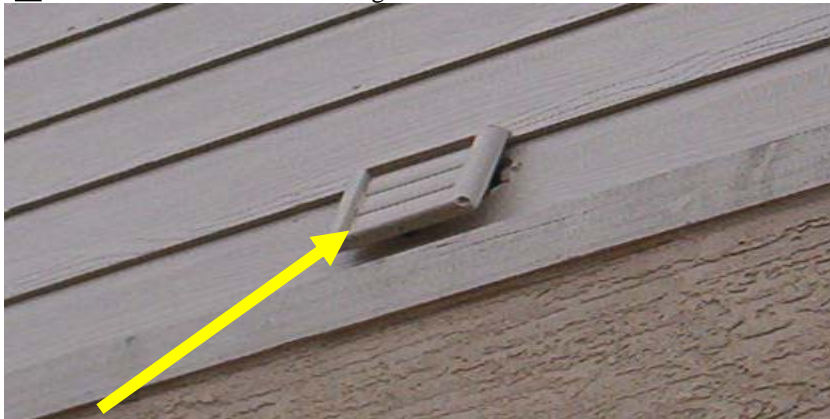
Loose exhaust fan from master bathroom

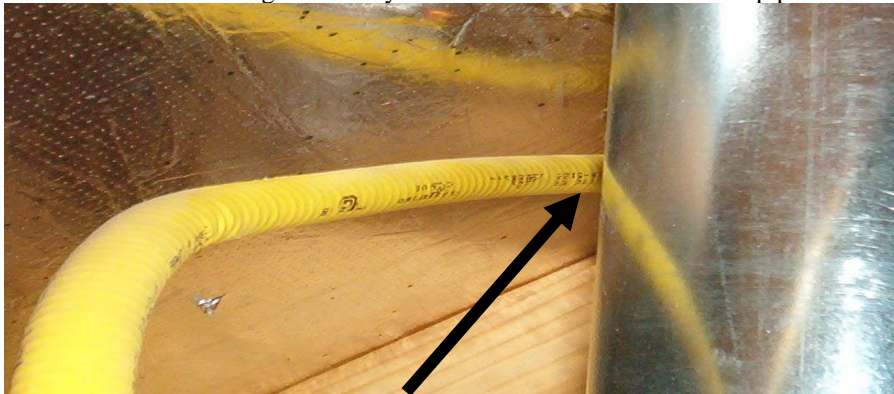
It was noted a gas line very close to the furnace flue exhaust pipe.

Flex gas line close to furnace exhaust flue pipe
